SERVICE BULLETIN

APPLICABILITY: 2013MY BRZ with FA Engine **NUMBER:** 02-136-12R
SUBJECT: Oil Seepage Diagnosis and Repair Procedures **DATE:** 09/26/12
REVISED: 10/02/12

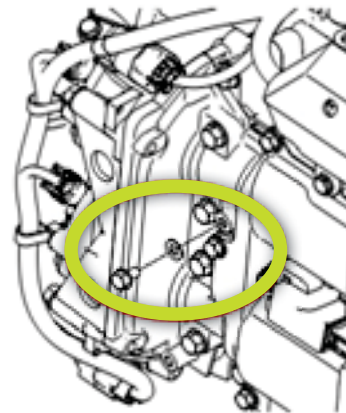
If oil seepage is verified coming from the 6mm threaded hole in the left-hand camshaft cap, install the specified bolt and flat washer.

Bolt: Part# 800206180

Washer: Part# 031106000

Tightening Torque: 6.4 +/- 0.5 Nm
(57 +/- 4 inch-pounds)

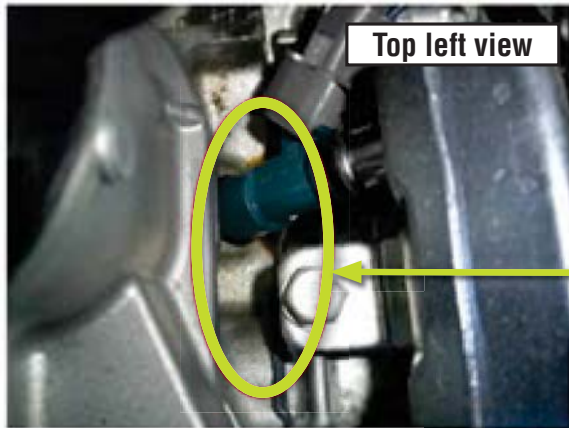
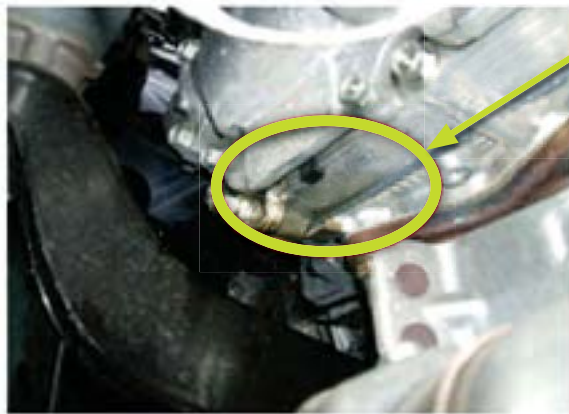
Cam carrier seepage seen from top left and lower right side of engine

If oil seepage is verified coming from between the cam carrier and the cylinder head as shown in the photos below, remove the cam carrier. Clean the machined sealing surfaces thoroughly and then re-seal using Liquid Gasket ThreeBond 1280B (Part No. SOA5499100) or equivalent*. As shown in the photos below, the o-rings between the cam carrier and the cylinder head will need to be replaced as they are not re-usable. This would also be a good time to clean the Active Valve Control System (AVCS) filter screens which are contained in the cam carriers and shown in the photos below. **NOTE:** The filter screens are one-time use and must be replaced if they need to be removed. The replacement filter part # is 14451 AA 050.

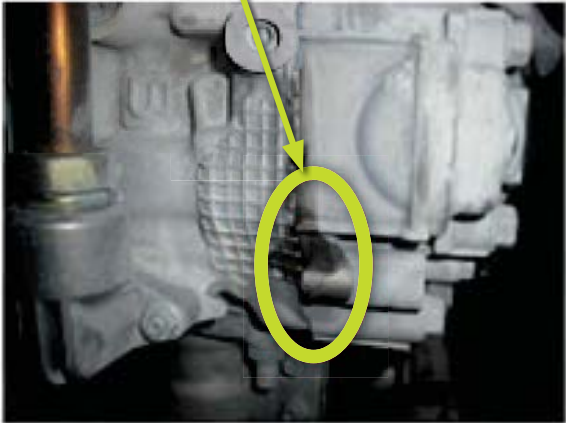
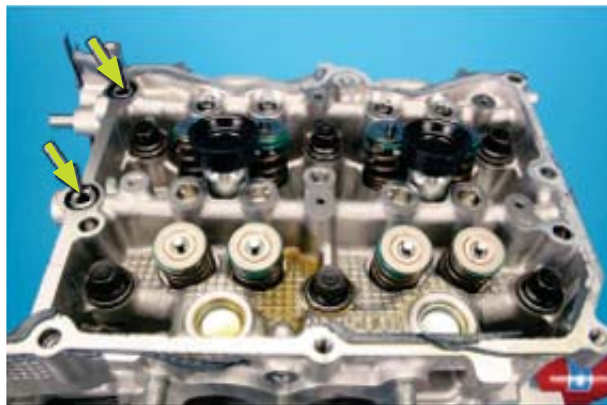
One-time use cam carrier o-rings which must be replaced.

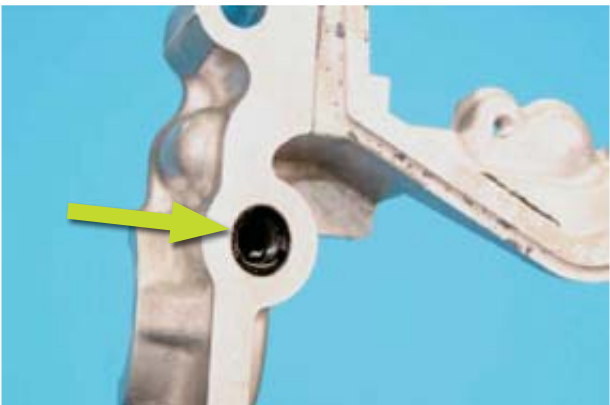
AVCS filter screens must be replaced if removed.

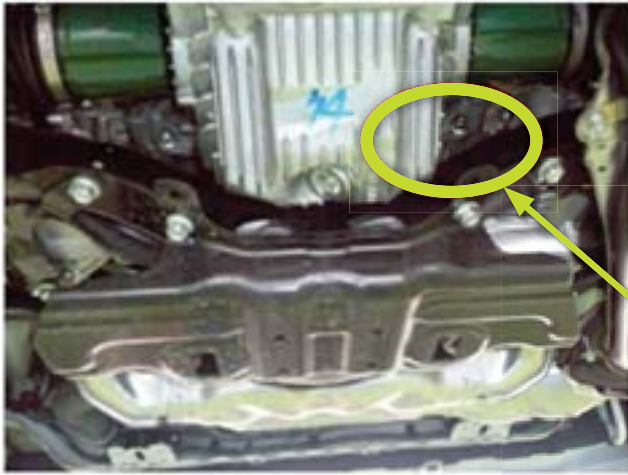
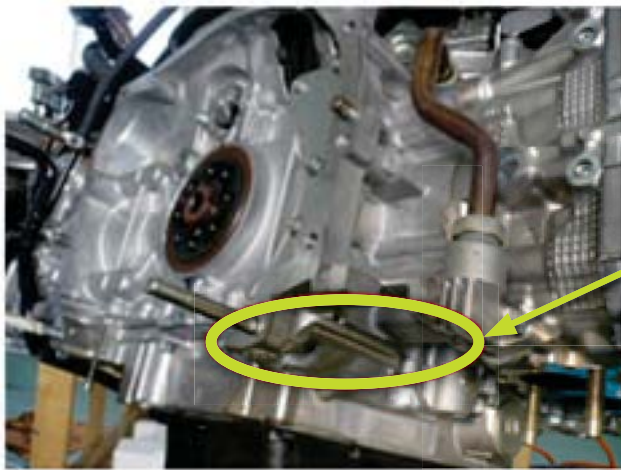
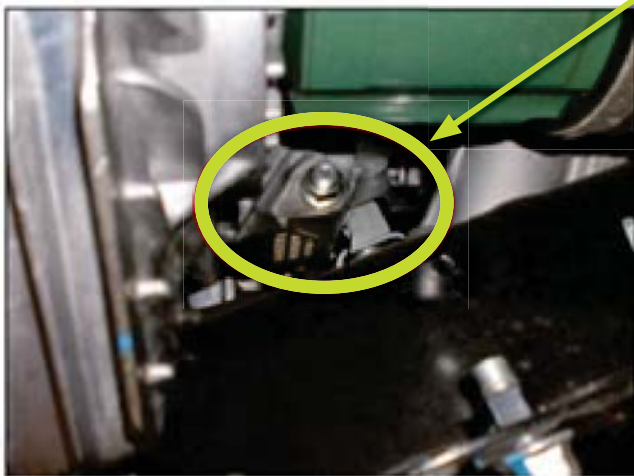
These photos show areas of seepage coming from the upper oil pan to engine block sealing surfaces.

If you find oil seepage between the cylinder block and upper oil pan, remove the upper oil pan, clean the machined sealing surfaces thoroughly and then re-seal using Liquid Gasket ThreeBond 1280B (Part No. SOA5499100) or equivalent*. In addition, the o-rings between the upper oil pan and the cylinder block along with those between the upper and lower oil pan will need to be replaced as they are also one-time use items.

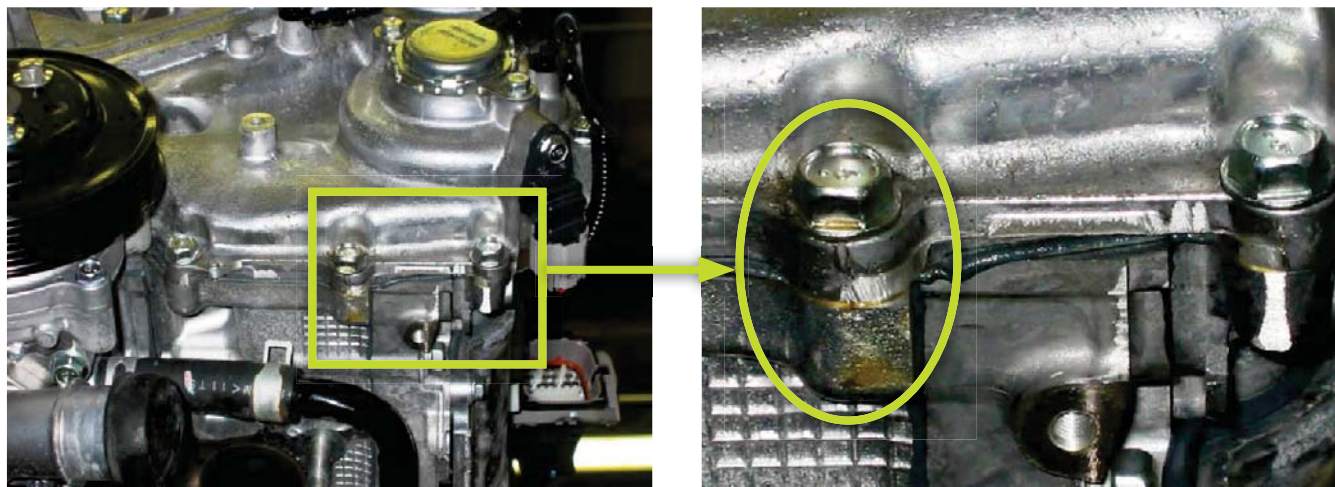
NOTE: Only reseal the front chain cover **AFTER** confirming there is no oil seepage coming from the either cam retainer cap (area 1) and / or the cam carrier (area 3) as previously described.

1. If there are no oil droplets found on the engine under-cover or the lower radiator hose, thoroughly clean the chain cover sealing area along with the surrounding cylinder head and crankcase areas. Re-check for oil seepage again at the next service interval.
2. If the front chain cover is leaking and needs to be resealed, follow the repair procedure in the applicable Service Manual. Thoroughly clean and inspect the sealing surfaces then re-seal using Liquid Gasket ThreeBond 1280B (Part No. SOA5499100) or equivalent*.
