SERVICE BULLETIN

APPLICABILITY: 2013-14MY BRZ

NUMBER: 09-54-12R

SUBJECT: High-Pitched “Chirp,” “Squeak” or “Cricket” Sound from the Engine

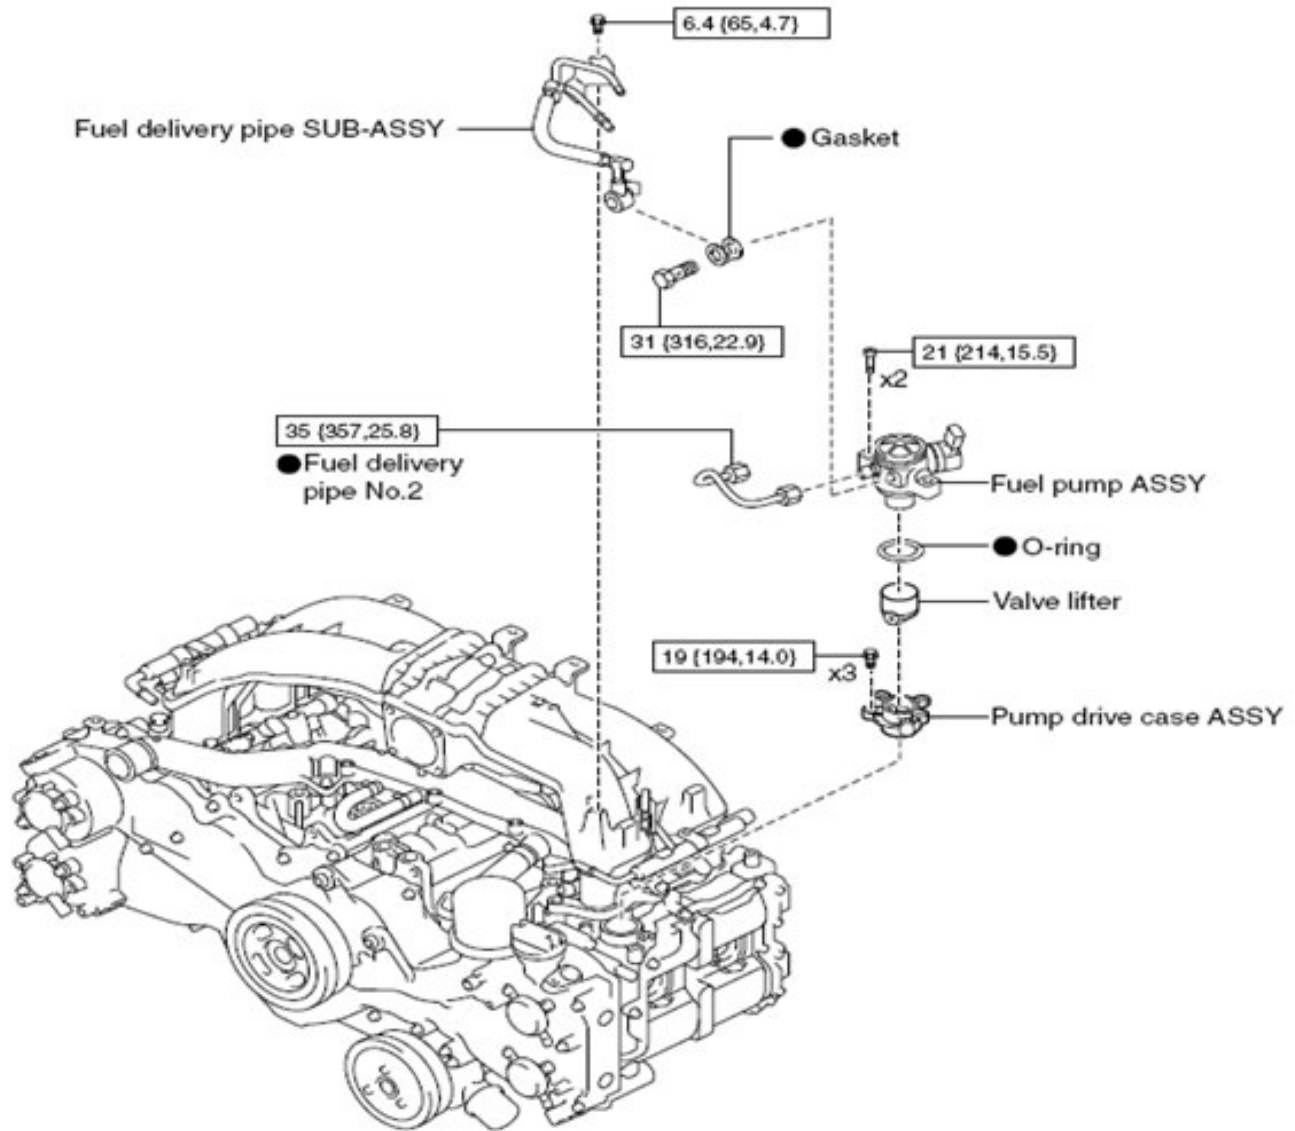
- Items indicated in the exploded view with a ● are “non-reusable” and **MUST** be replaced.
- The o-ring is included with the fuel pump assembly.
- Part numbers and quantity required to complete the procedure are listed below.

IMPORTANT: Always follow the tightening torque specifications as indicated in the applicable Service Manual (and the exploded view diagram on pg. 2) during re-assembly.
