SERVICE BULLETIN

APPLICABILITY: 2013MY BRZ

NUMBER: 09-54-12R

SUBJECT: High-Pitched “Chirp,” “Squeak” or “Cricket”
 Sound from the Engine

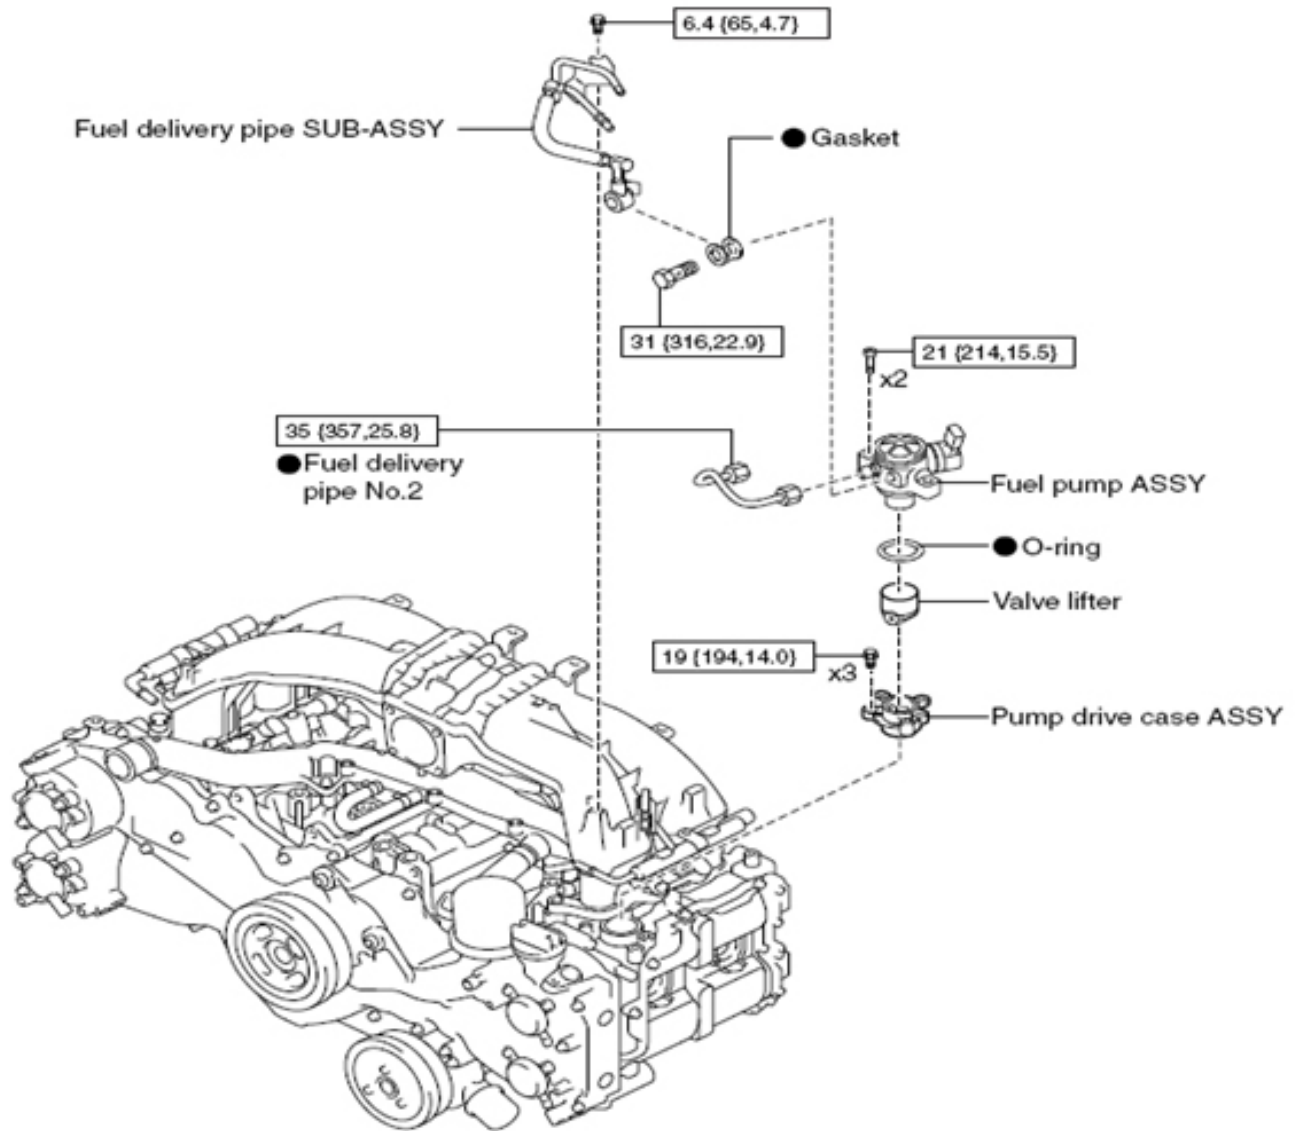
- Items indicated in the exploded view with a ● are “non-reusable” and **MUST** be replaced.
- The o-ring is included with the fuel pump assembly.
- Part numbers and quantity required to complete the procedure are listed below.

IMPORTANT: Always follow the tightening torque specifications as indicated in the applicable Service Manual (and the exploded view diagram on pg. 2) during re-assembly.
