SERVICE BULLETIN

APPLICABILITY: 2013MY BRZ NUMBER: 12-131-12

SUBJECT: Condensation in Rear Combination Lamp **DATE:** 06/12/12

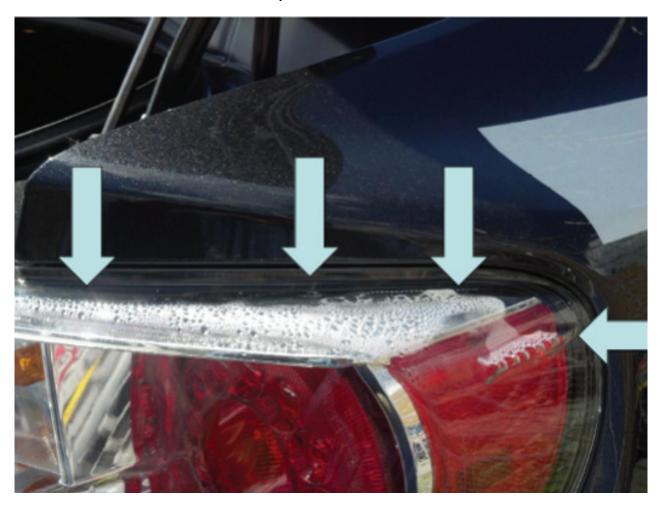
If you encounter a vehicle which has condensation in the rear combination lamp(s) the boss that houses the mounting stud may be cracked. To verify the condition, the combination lamp will need to be removed and inspected.

Example of condensation
