SERVICE BULLETIN

APPLICABILITY: 2013MY BRZ **NUMBER:** 15-158-12
SUBJECT: Navigation/GPS Antenna Changes **DATE:** 10/24/12
 SD Card Exchange Program Information

INTRODUCTION

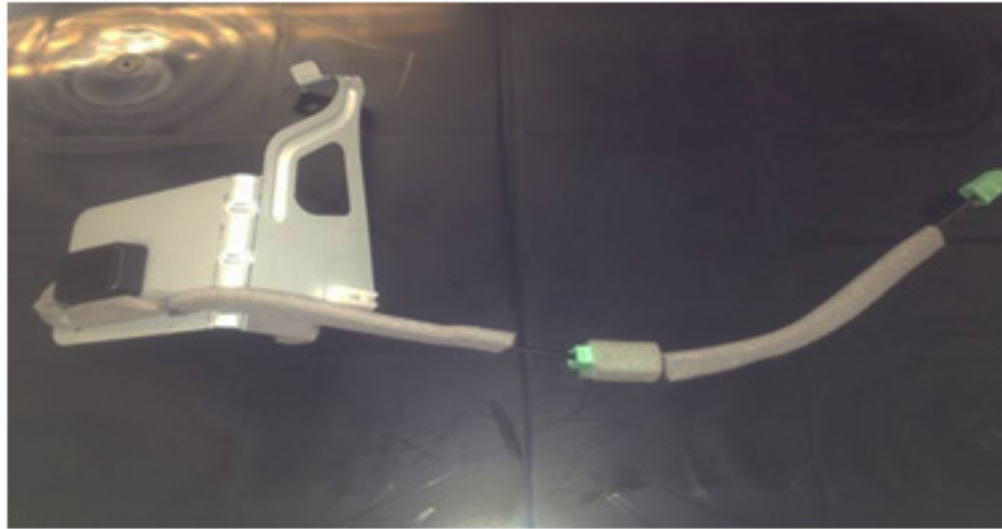
The photo below shows the revised GPS antenna / mounting bracket assembly along with an antenna lead extension harness already attached. **NOTE:** The revised GPS antenna / mounting bracket assembly you receive may have a longer 1-piece lead instead of a shorter lead with an extension pigtail as shown in the photo. Either configuration is acceptable to use for this procedure.
