S-SB-0002-13

January 16, 2013

# Moisture in Rear Combination Light / Water Intrusion Into Vehicle

YEAR(S)	MODEL(S)	ADDITIONAL INFORMATION
2013	FR-S

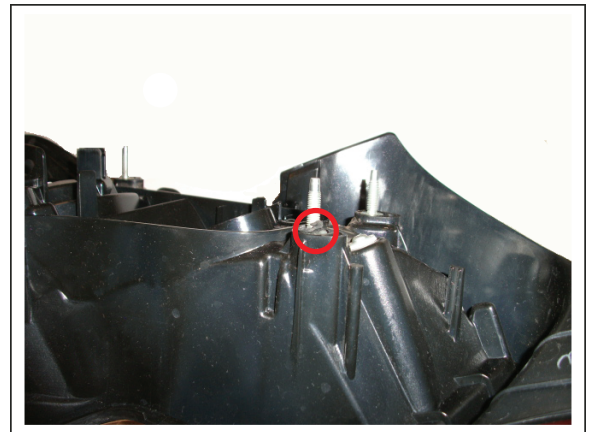
Figure 3.

6. Remove one or both lights that show evidence of moisture intrusion.
7. Inspect the back side of the combination lights for evidence of plastic cracking around the mounting studs. If cracking is present, replace the housing and the gasket.

The sealing gasket is a “ONE USE ONLY” type gasket and **MUST** be replaced every time a combination light housing is removed from the vehicle.

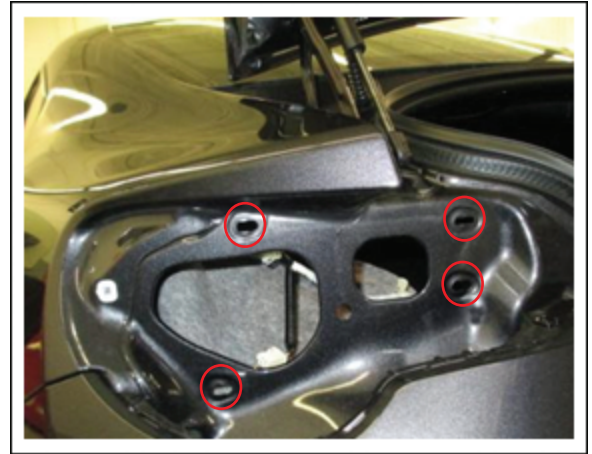
Figure 5.

2. Inspect the body sheet metal for evidence of deformed (cone shape) sheet metal around the 4 through-holes in the body.

Use a Body Hammer and Body Dolly to flatten the sheet metal around the 4 through-holes in the body (see circled areas for through-hole locations). Use touch-up paint on any bare metal areas.

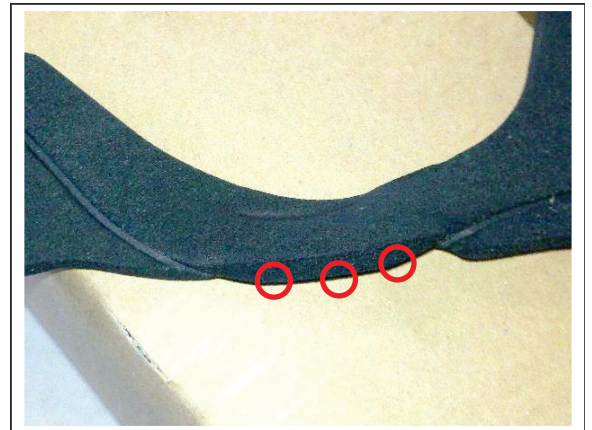
Figure 6.

3. Inspect the rear combination light sealing gasket for evidence of misplacement.

A misplaced gasket may allow water to enter the combination light housing or possibly the interior of the vehicle.

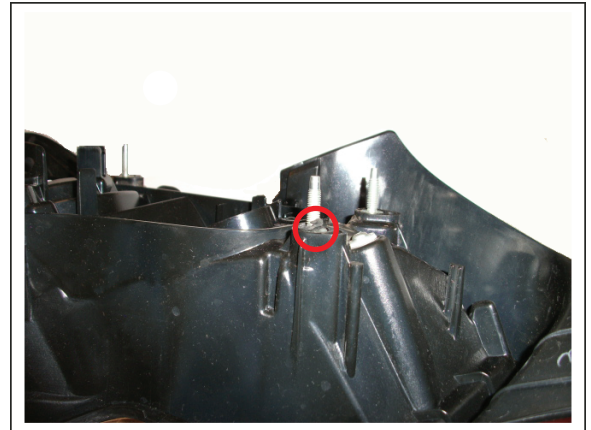
Figure 7.

4. Replace a rear combination light ONLY if it is damaged.

- If the cause of the water leak was misplaced seam sealer or a misplaced sealing gasket, carefully inspect the combination light housing for evidence of damage and if no damage is present, do NOT replace the housing, replace ONLY the sealing gasket.
- The sealing gasket is a “ONE USE ONLY” type gasket and **MUST** be replaced every time a combination light housing is removed from the vehicle.

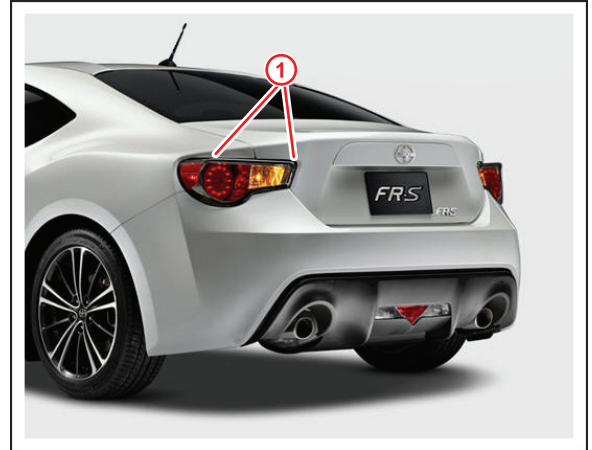
Figure 8.

7. Perform a final water test confirmation.
  - A. Spray water on the vehicle, especially around the perimeter of the light housings.
  - B. From inside the vehicle, confirm there is no water is leaking into the vehicle.
