S-SB-0019-12

# Dash Mounted Speaker Grille Appearance

YEAR(S)	MODEL(S)	ADDITIONAL INFORMATION
2013	FR-S

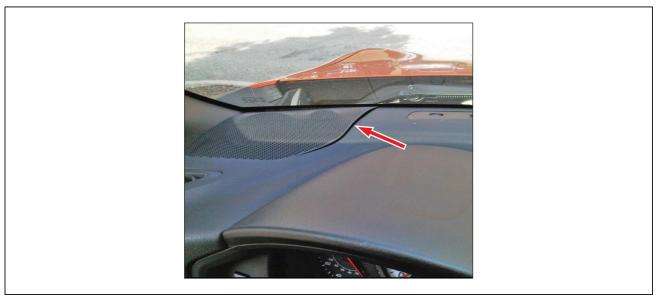
# Figure 1.

Some 2013 model year FR-S vehicles may exhibit a condition where the dash mounted speaker grille may appear to be over-flush to the top of the dash similar to the illustration below. This bulletin provides repair instructions to address the speaker grille over-flush condition.
