SERVICE BULLETIN

APPLICABILITY: 2013MY BRZ **NUMBER:** 15-158-12
SUBJECT: Navigation/GPS Antenna Changes **DATE:** 10/24/12
 SD Card Exchange Program Information

INTRODUCTION

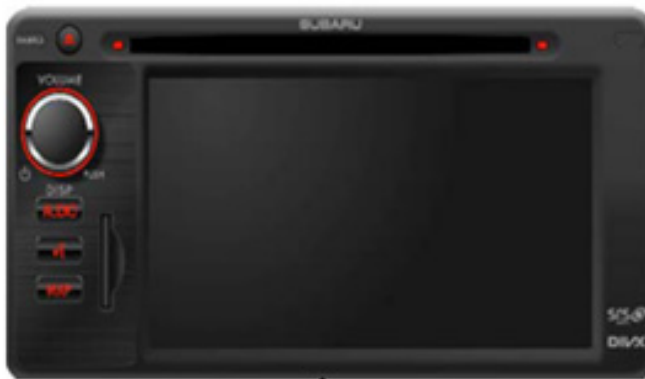
- **CAUTION:** Until the programming process is completed, do not turn the ignition key or push start switch off or attempt to start the engine. Any interruption during the programming process can damage the unit’s internal navigation data in which case, the audio / navigation unit will need to be replaced. After turning the ignition key or push-start switch on, the screen will remain black for about a minute while the reprogramming process is running. Once the status/loading bars complete and the “Version Up OK” message appears, cycle the ignition key off then back on to the “ACC” position.

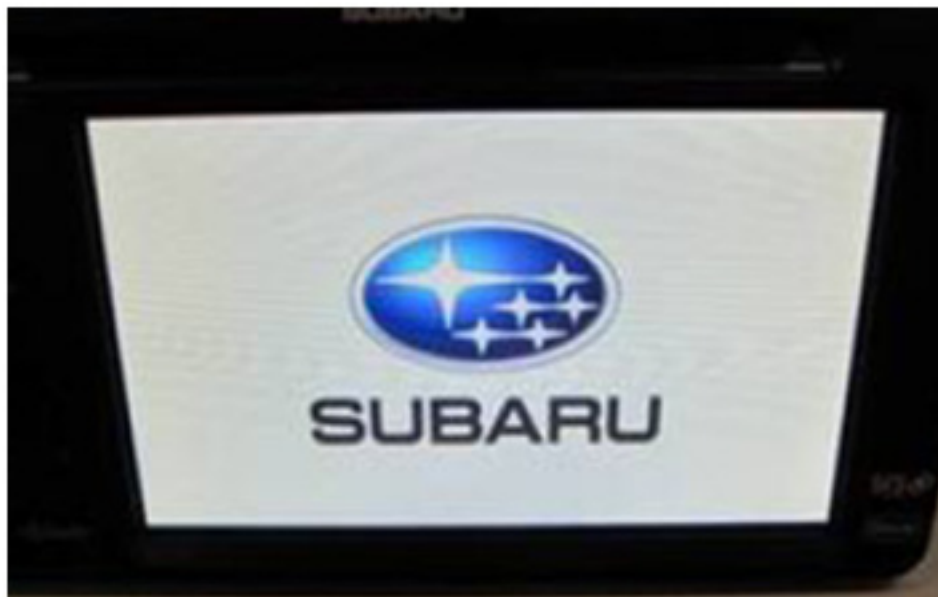
- **Step 5:** When the programming process has completed, the system will display the “Start-Up” screen.

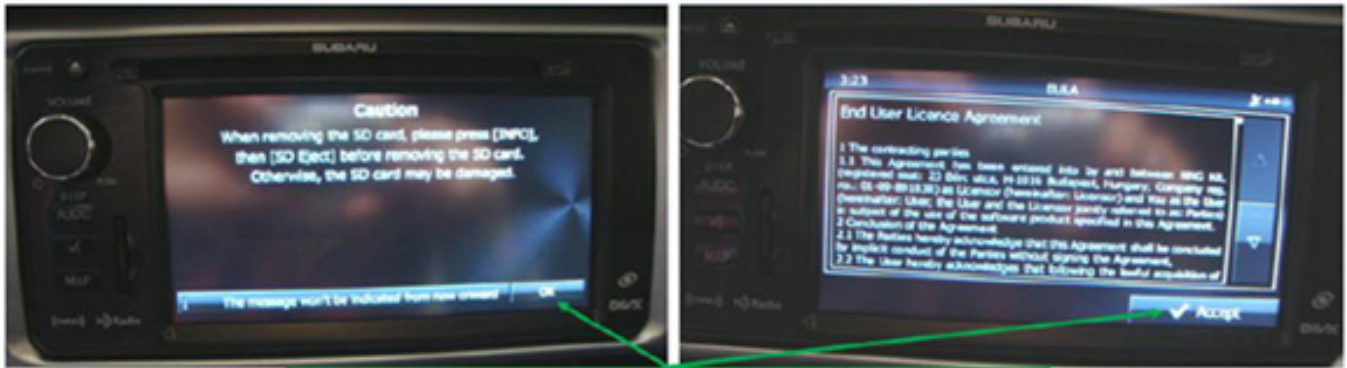
After start-up “Subaru” screen, toggle through two screens by selecting “OK” and “Accept”.

- **Step 6:** After the “Start-Up” screen, the “Caution” and “End User License” screens will appear next. Press “OK” then, press “Accept” as shown below.
